HubLine Impact Assessment, Mitigation, and Restoration

Annual Progress Report of the *Massachusetts Division of Marine Fisheries* to the Executive Office of Environmental Affairs

**Period Covered:
May 31, 2003-June 30, 2004**

***Marine Fisheries'* Annual Progress Report for Year 1**

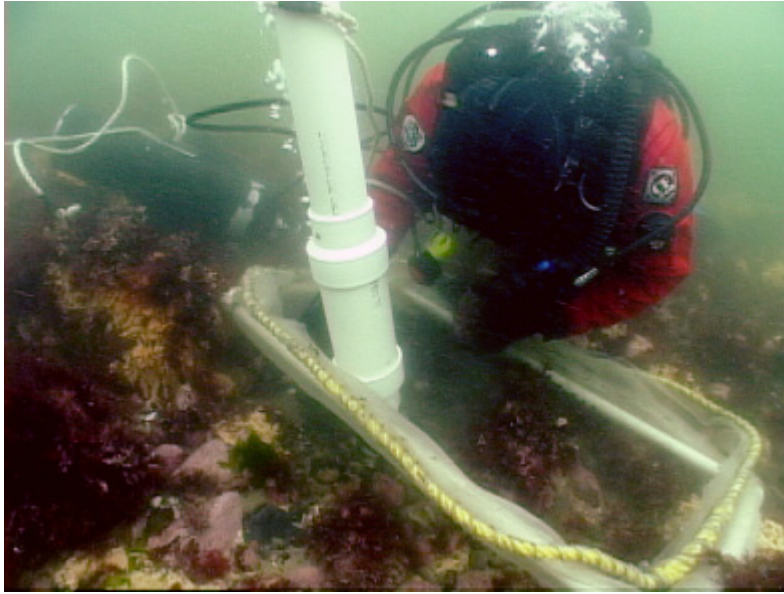
Figure 6. View of typical SCUBA suctioning operation within a 1/2 m² quadrat.

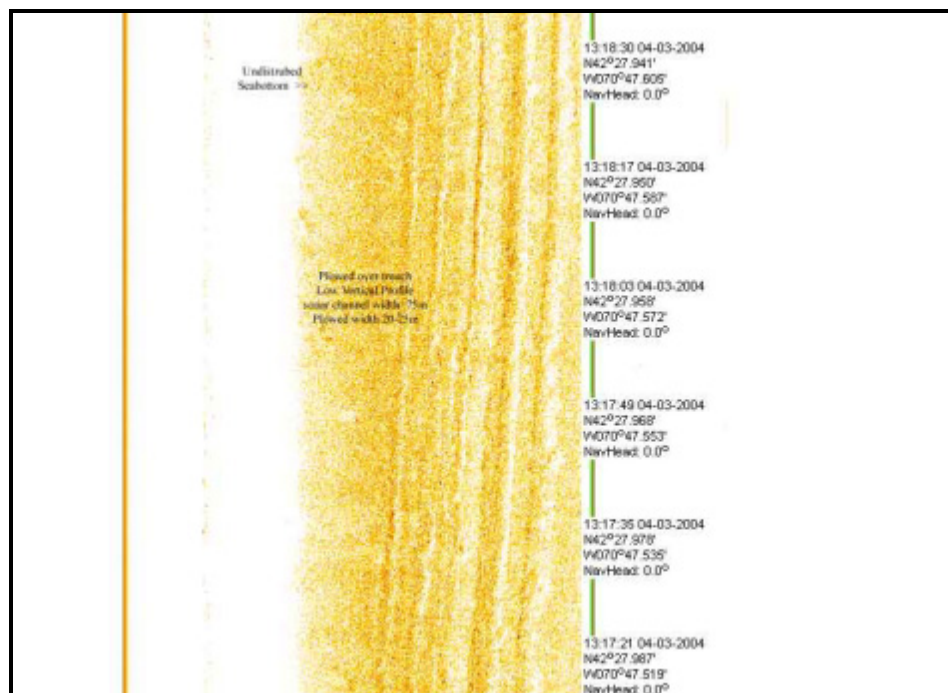
Figure 12. Sonar image of soft sediment back-filled area of HubLine path with low vertical relief.

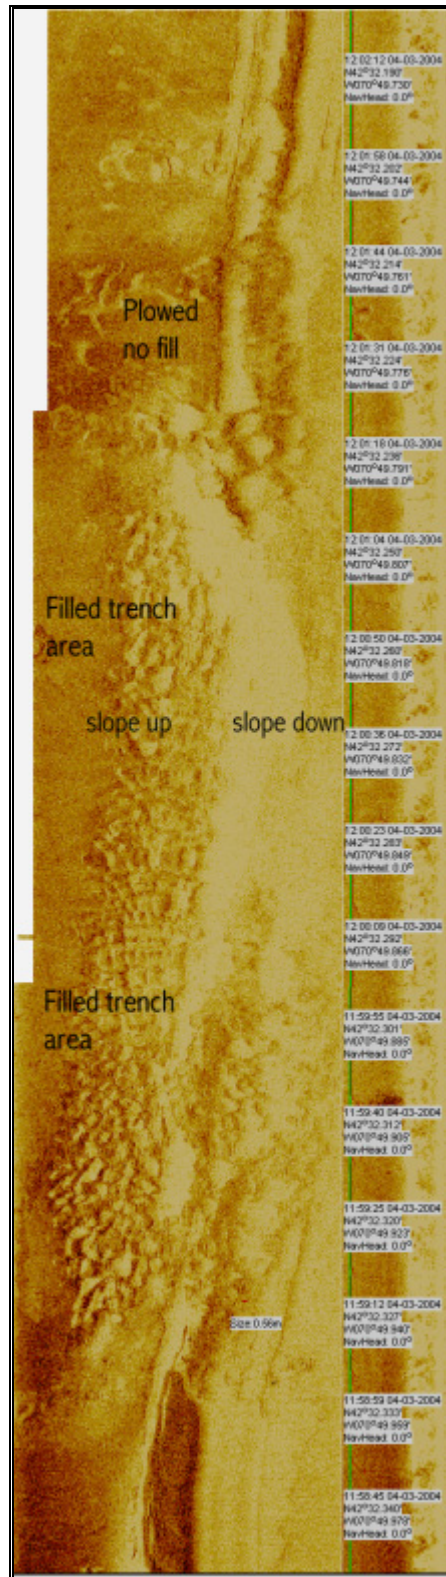
Figure 13. Sonar image of complex environment along HubLine pipeline trench which depicts an area of fill with plowed areas on either side.

Sonar and video imaging indicate that the disturbed habitat along the 29.4-mile path has not yet been restored to pre-construction quality. Also, width of the area of disturbed sediments along the pathway generally exceeds estimates provided during the pre-construction review process and approaches 25 m (75ft). This is important information relative to evaluation of the impact of future similar marine construction projects. There is a considerable amount of relief which is evident in elongated spoil piles which are 1-2m in elevation. Figure 11 provides an example of this. It is conceivable that soft-bottom sediments which are disturbed in this manner may be modified and/or leveled by currents and storm surge (Figure 12). However, areas with comparatively low current velocity or deeper water sediments which are less affected by strong winds, particularly hard bottom, e.g., cobble sediments, may not recover naturally. This needs to be considered for future projects of this nature. Other locations along the back-filled pipeline trench which received fill and represent a complex environment provide opportunities for future monitoring efforts (Figure 13).

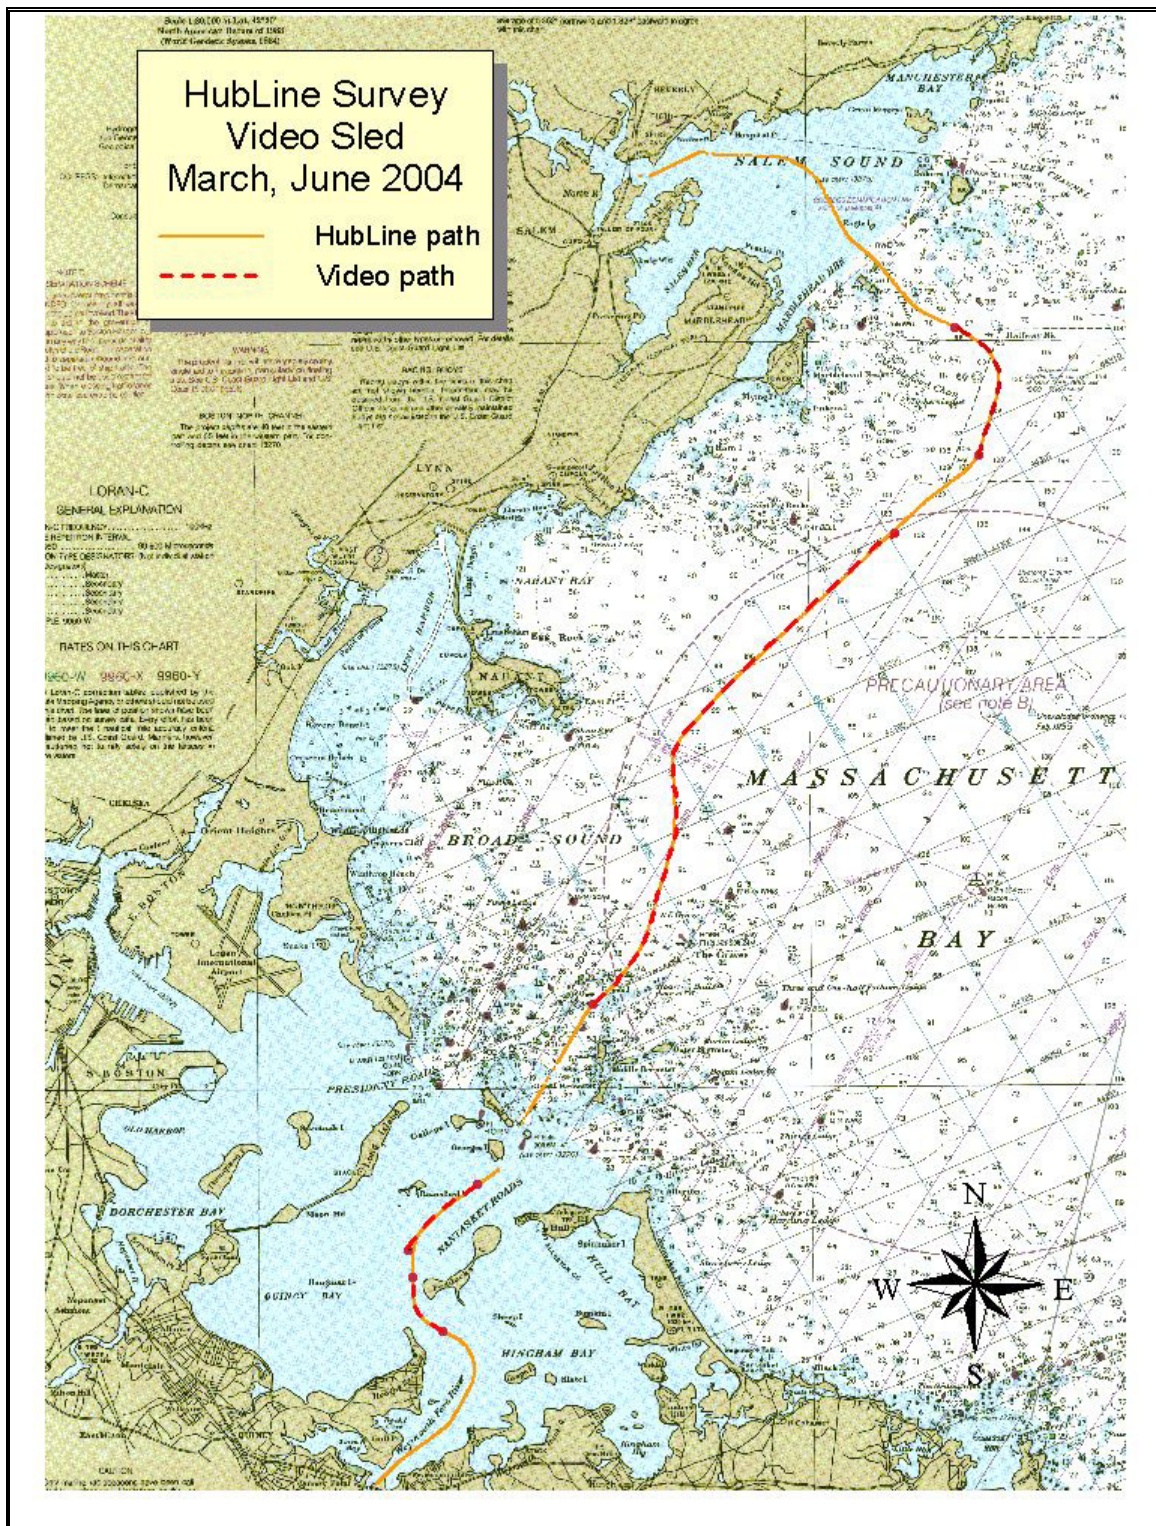
Figure 14. Video sled survey conducted along HubLine pathway during March and June, 2004.

Sonar and video sled imaging were the principal applications intended for the March, April, and June surveys (Figure 14), but the intended emphasis was primarily on video. Video imagery was attempted in more than three locations during the April survey, however a northeast storm, swells, and heavy rains prior to and during the survey prevented successful deployment of the video system in both a drift and a towed mode. The rain is suspected of lowering underwater visibility to equal or less than two feet in the more inshore survey areas. The swell caused the video towfish assembly to move vertically in the water column. Very low underwater visibility concomitant with the unstable vertical movement of the towfish precluded much of the deployment of the video towfish system during the April survey period. The June 2004 video survey shows a considerable amount of the disturbed HubLine pathway at depths greater than 20ft MLW. These views were targeted at sites that were selected from sonar records and some video acquired during the March 2004 survey.

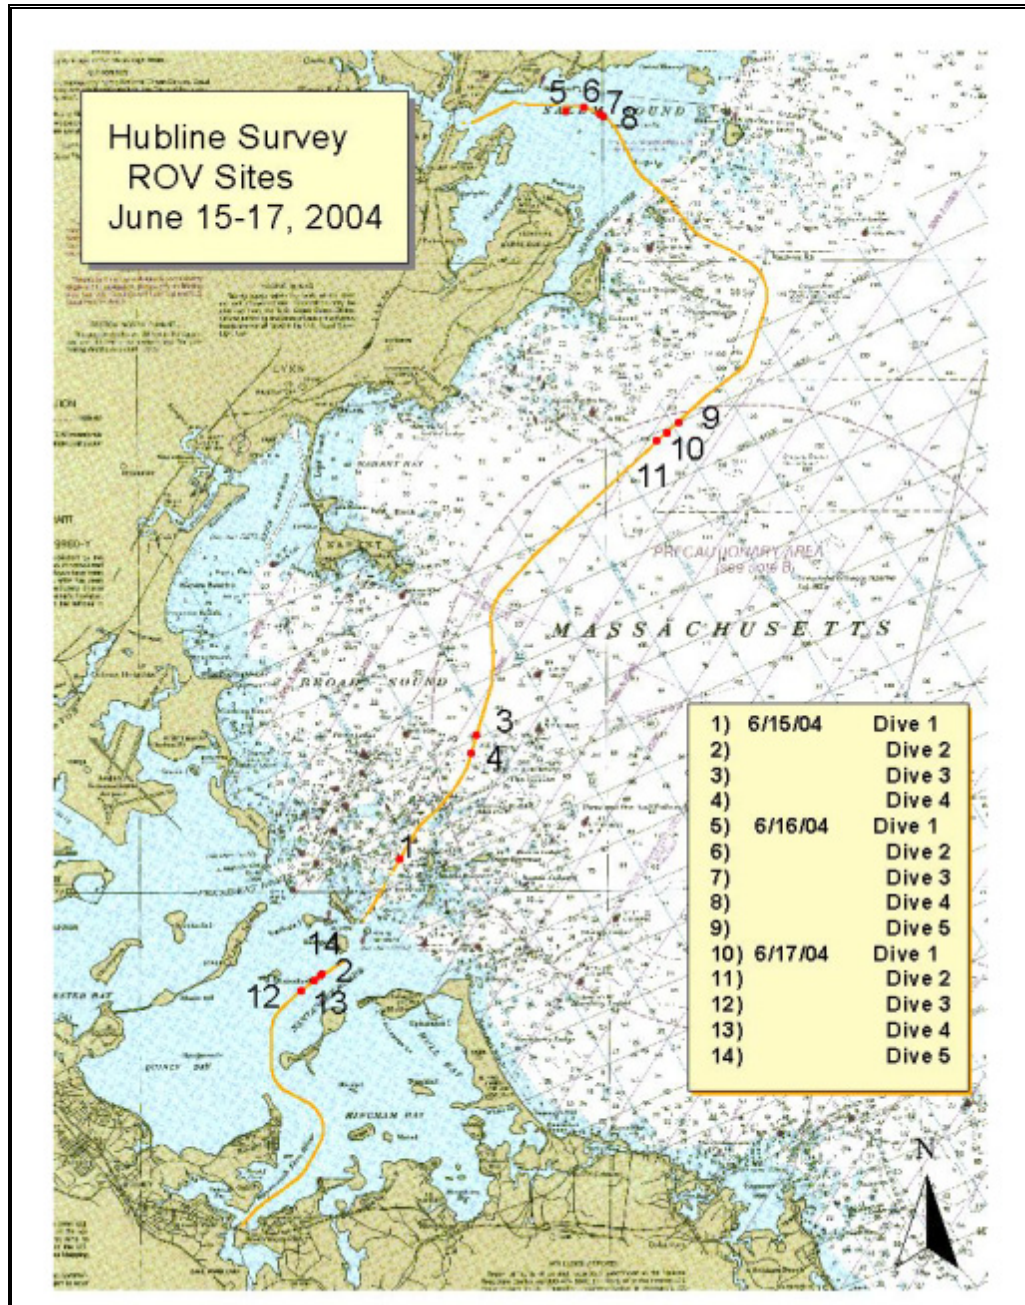
Figure 15. ROV dives conducted along HubLine pathway during June 15-17, 2004.

Fourteen ROV dives were conducted during June 15-17, 2004 at sites established on the basis of our previous sonar surveys. These sites are intended as potential future "monitoring posts" (Figure 15) and represent an array of habitat types, but are not yet considered to be a complete set at this time. A significant amount of imaging data has been collected to date and further analysis may generate additional locations of interest to monitor recovery. A description of these sites via HubLine sonar records taken by AUSS and preliminary general descriptions with accompanying ROV video accounts are displayed in Appendix C below. All sonar records are taken at a frequency of 500kHz, unless mentioned otherwise.

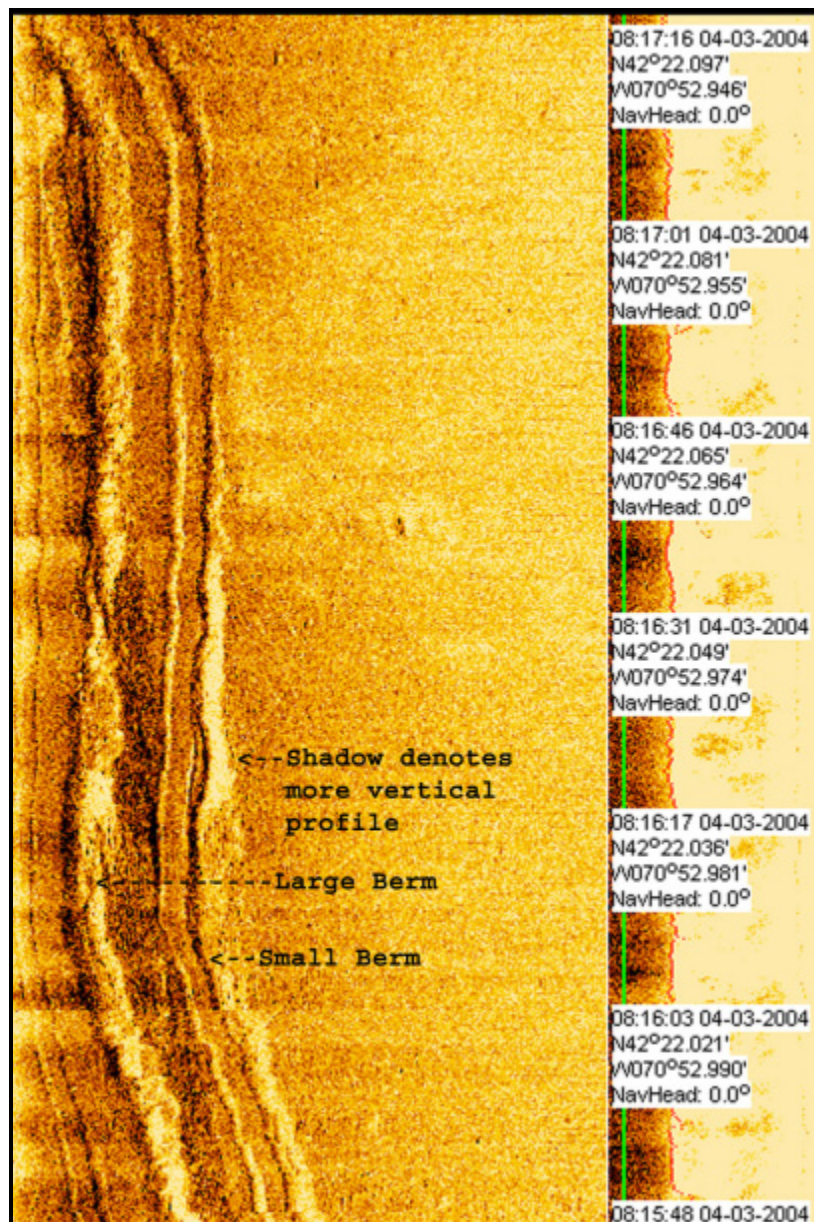
Sonar Record Description for Dive 4: The clear insonification of the trench and plowed area is 25m wide. Two low berms (<1m high) lay inside and outside of the skid path and one major berm (>1m) lies in the middle of the path. Sea conditions produced some heave effect on the record; this in evidence by a slight wobbling effect in the record.

Video Record Description for Dive 4: Just east of the Dive 3 site; designated as B-6. Coordinates: 42 22.1N / 070 52.9W. Trenched area and berms; cobble and clay.

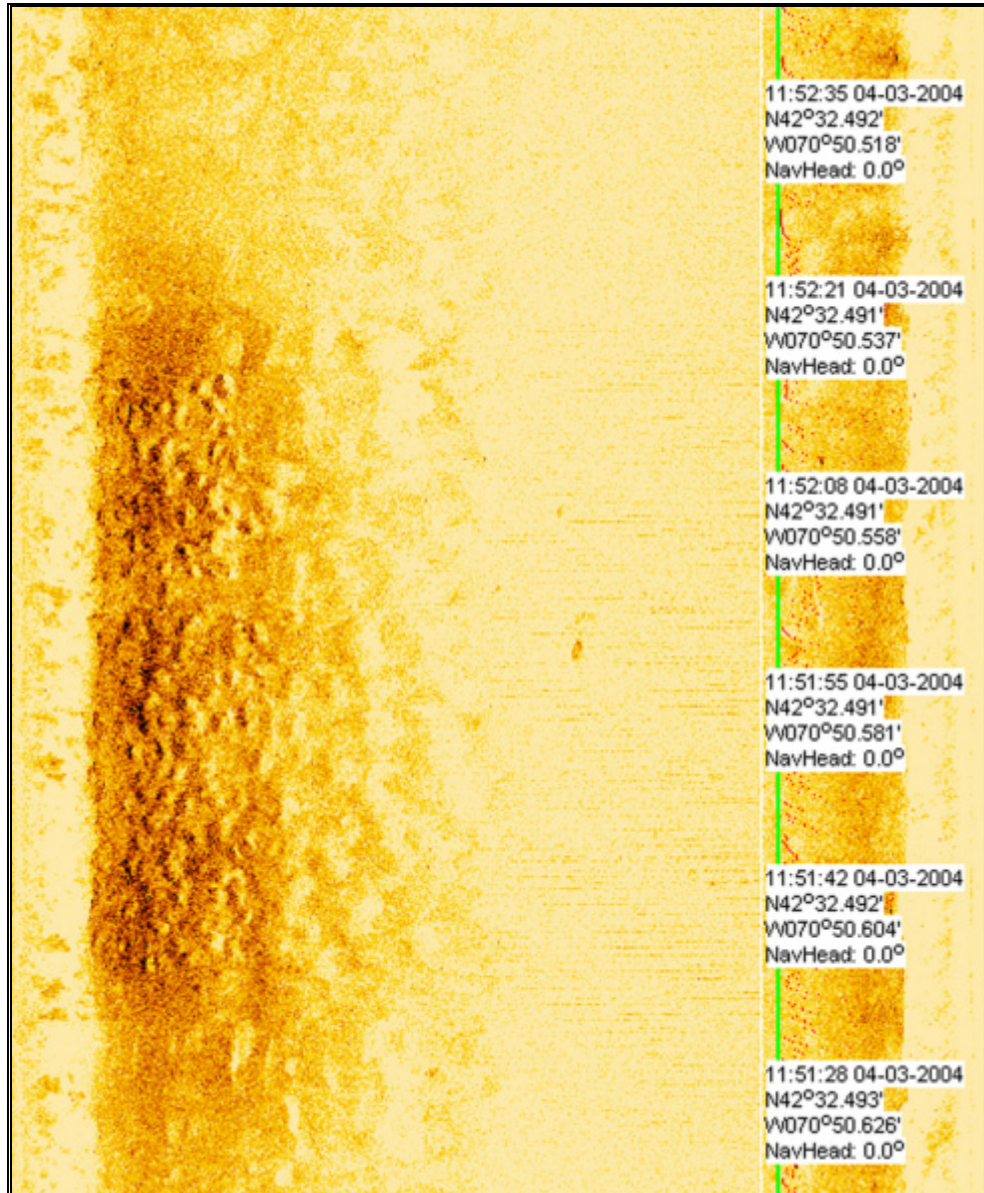
C-07Dive1,0616: (Sonar record source:hubsouth1,04/08/04)

Sonar Record Description for Dive 1: This is a 500kHz record showing a fill area with the dimensions of 130m by 35m. Some of the irregular fill shows a darker return; this is fill that has an upward face to the sonar source (sloping up as it is further away from the sonar source). The lighter and less defined fill further to the right is sloping down toward the natural seabottom depth.

Video Record Description for Dive 1: Site designated as C-07; Coordinates: 42 32.4N / 070 50.79W
Previously described as an area that was filled and a transition zone. Little was seen, at first, that may relate to the trenching but near the end of the dive we viewed a major disturbed depression that had collected algae, Laminaria, etc.

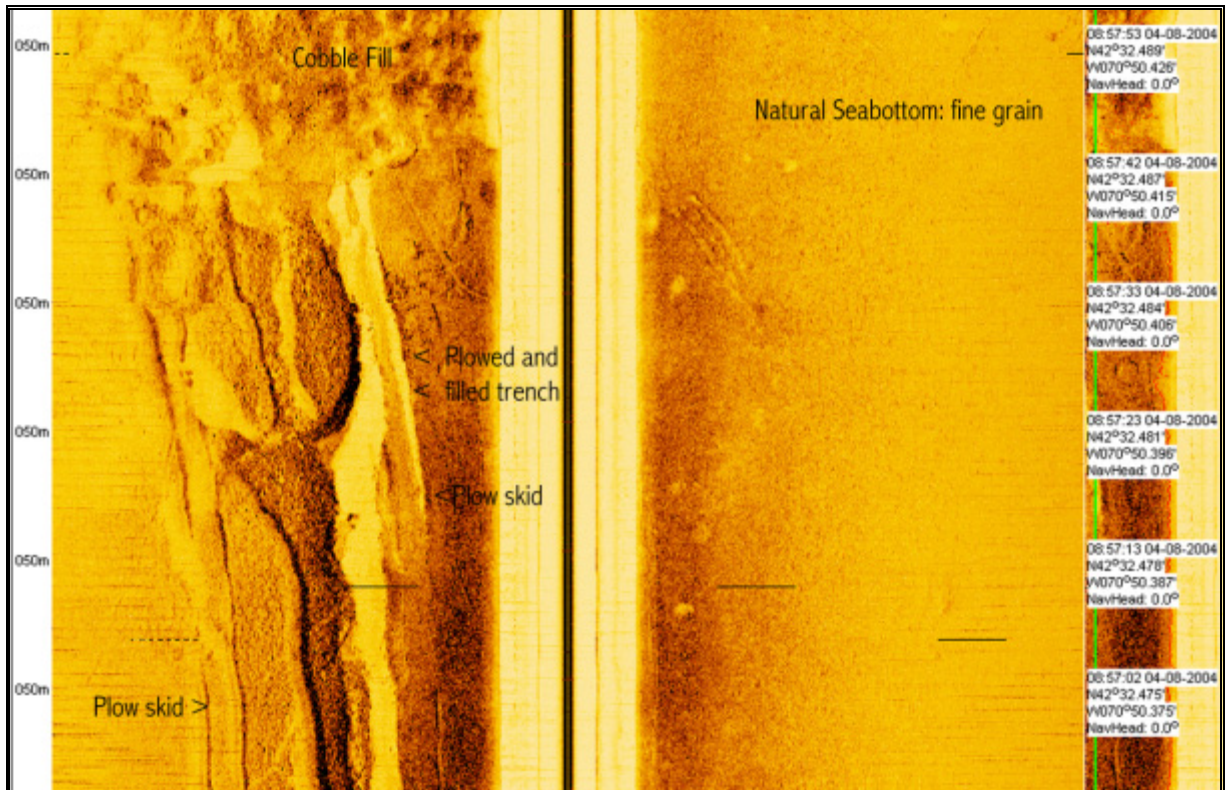
C-08, Dive2, 0616:

Video Record Description Dive 2: Site designated as C-08 Coordinates: 42 32.5N / 070 50.4W

This was a site previously labeled as complex. The trenching left the site quite disturbed and of varying depth. The tape recording shows much cobble and depressions and little marine life.

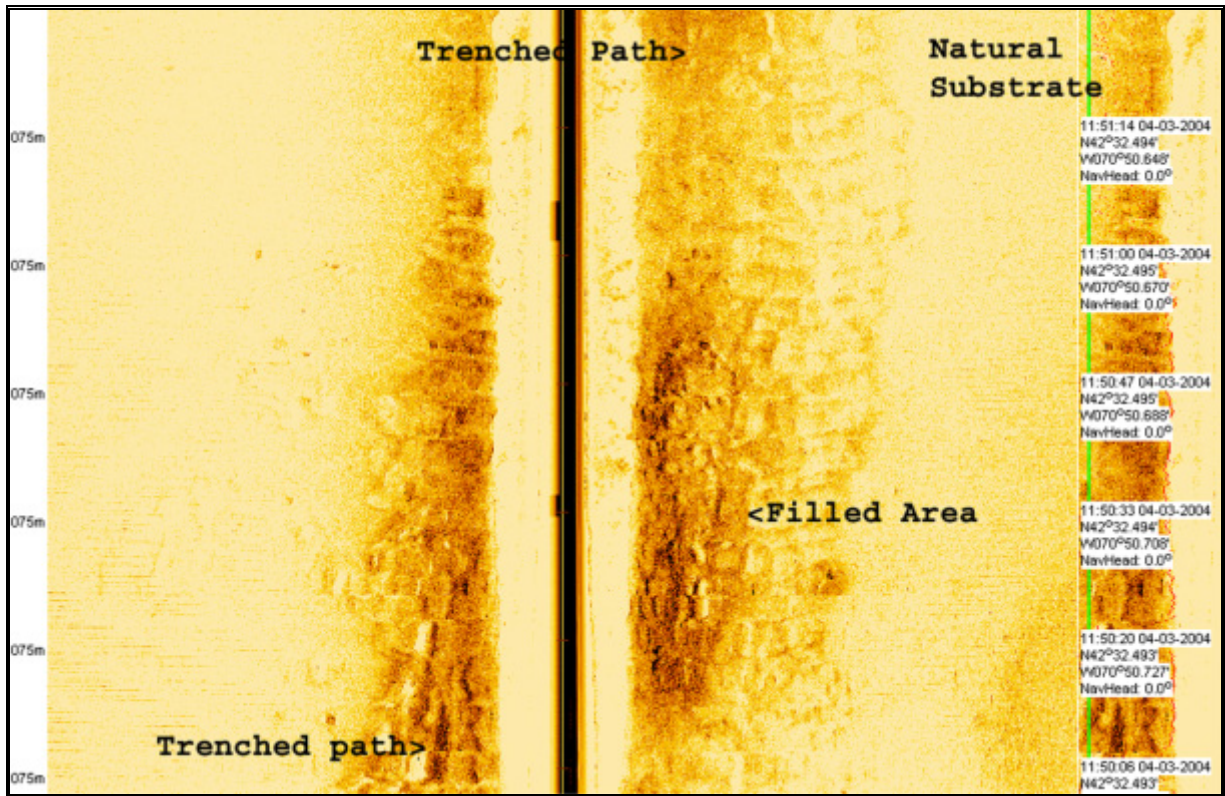
C-09Dive3,0616: (Sonar record source:hubsouth1, 04/08/04)

Sonar Record Description for Dive 3: The fill area depicted measures about 83m by 28m. It represents only a portion of the fill in that immediate area. The seabottom shown at the sides of the picture is the natural flat and less irregular substrate.

Video Record Description Dive 3: Site designated as C-09 Coordinates: 42 32.35N / 070 50.66W
A previously designated site for optical survey. It consisted of cobble with more colonization of attached bryozoans and hydroids than previously seen cobble. Cobble berms and depressions viewed.

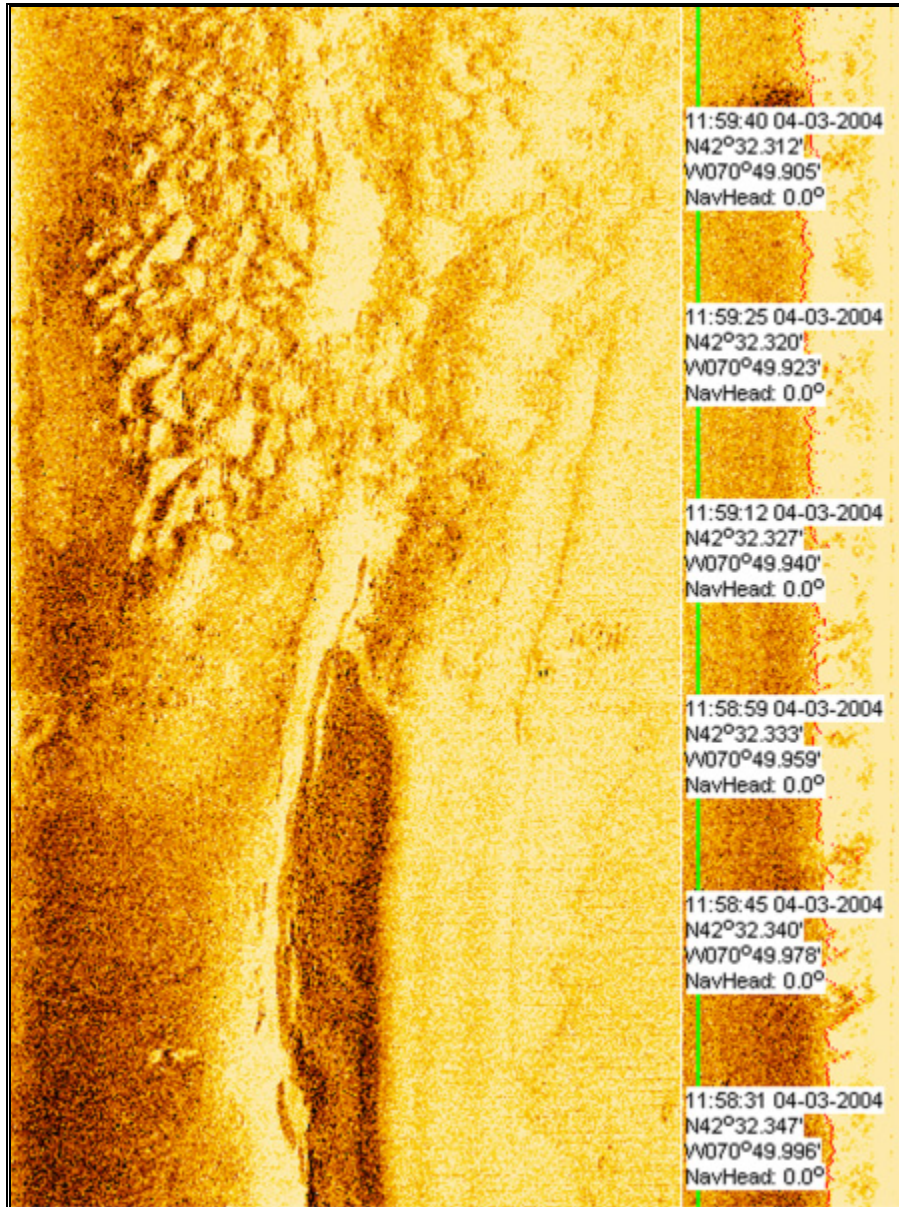
C-10Dive4,0616: (Sonar record source:hubsouth1,04/08/04)

Sonar Record Description for Dive 4: The width of this record is 75m. The upper portion of the record is an area that was covered with fill. The lower portion shows the remnants of the plow activity. The left part of the record, that is darker, shows more of an upslope as it progresses to the right and then a downslope progression further to the right. In the plowed area the upslope appears to change to a downslope along the center of the plowed path.

Video Record Description Dive 4: Site designated as C-10 Coordinates: 42 32.3N / 070 49.9W

The sonar survey described this area as a transition zone that was probably filled after trenching. The video showed a good profile of the trench, sandy bottom and cobble.

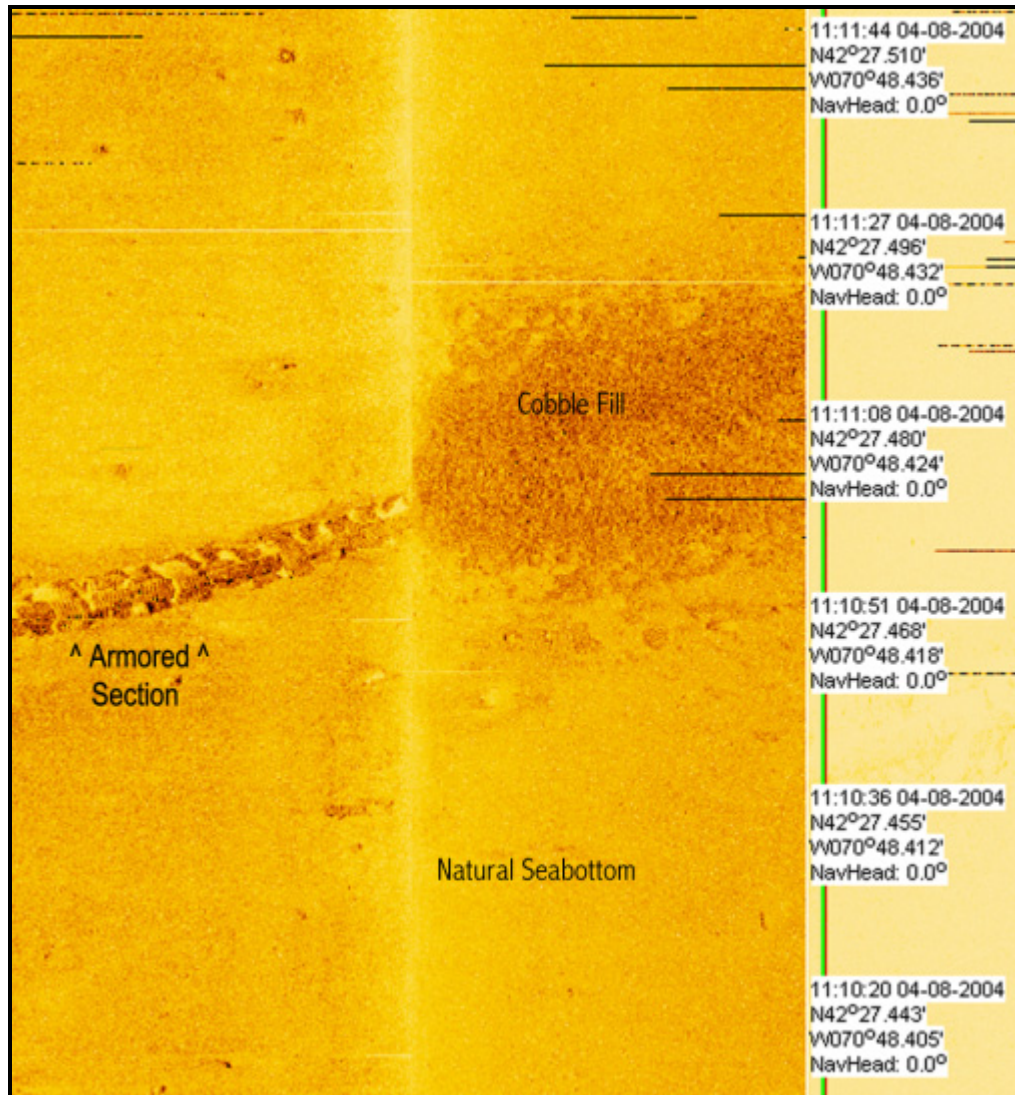
C-14Dive5,0616

Coordinates: 42 27.43N / 070 48.46W

The records show natural bottom and armored sections. The latter is concrete “blocks” connected to form mats. Some cunners, a sculpin and a flounder were viewed; no lobsters or other crustaceans.

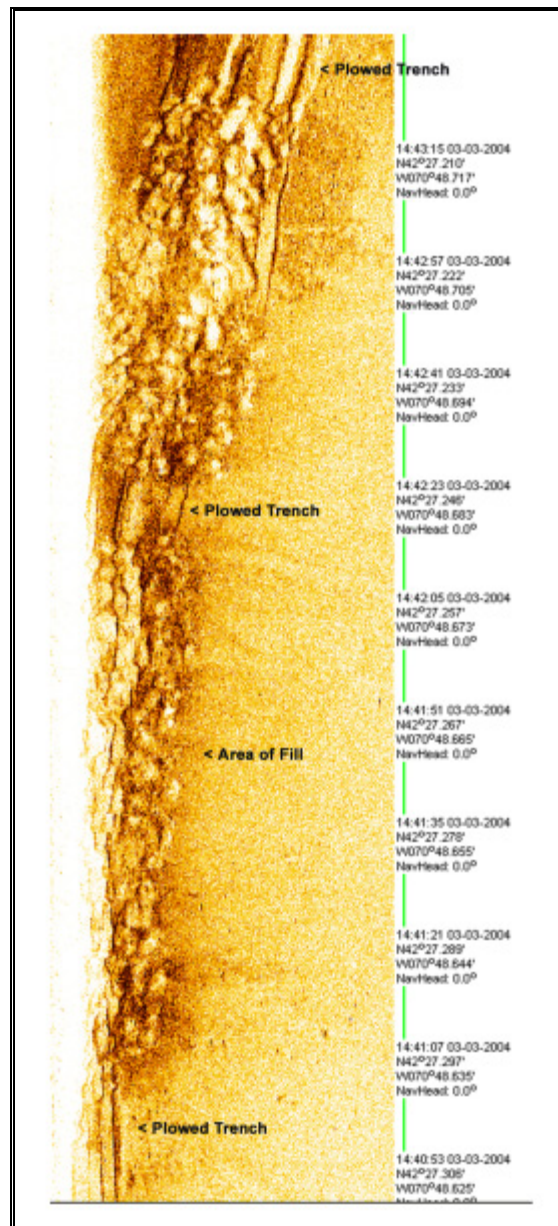
C17-18Dive1,0617

Video Record Description for Dive 1: Site designated as C-17, C-18 Coordinates: 42 27.3N 070 48.7W

This site was previously recommended for a video survey as it represented an area that was a combination of plowed and filled with cobble. The sonar showed clear examples of this representation. The ROV dive viewed good representations of cobble and natural bottom. Some marine life was seen. This included ocean pout, sculpin, cunner, and a lobster.

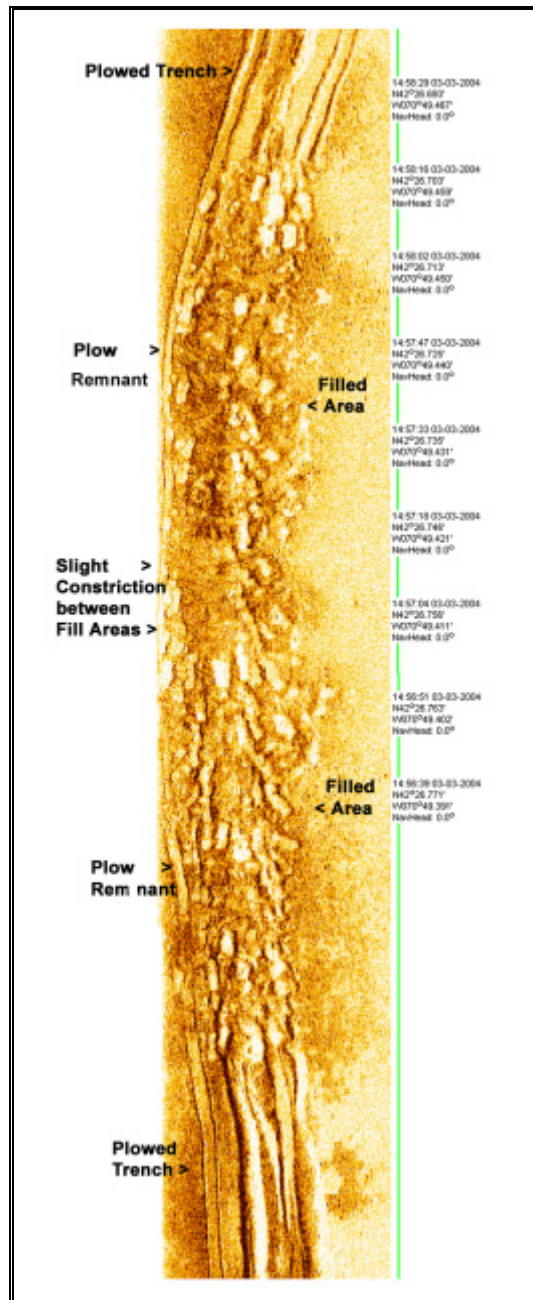
C19-20, Dive2, 0617

Sonar Record Description for Dive 2: This site is similar to the previous site: it has two cobble filled mounds along the trenched area. The difference is that the mounds are slightly separated with essentially no plowed trench path between them. Some remnants of the plow track are seen along the left side of the mounds.

Video Record Description for Dive 2: Site designated as C-19, C-20 Coordinates: 42 27.1N / 070 48.9W
This site is adjacent to the Dive 1 site and reflects the same characteristics as previously seen by sonar. The ROV dive saw natural bottom, some near vertical relief with cobble and some cunner.

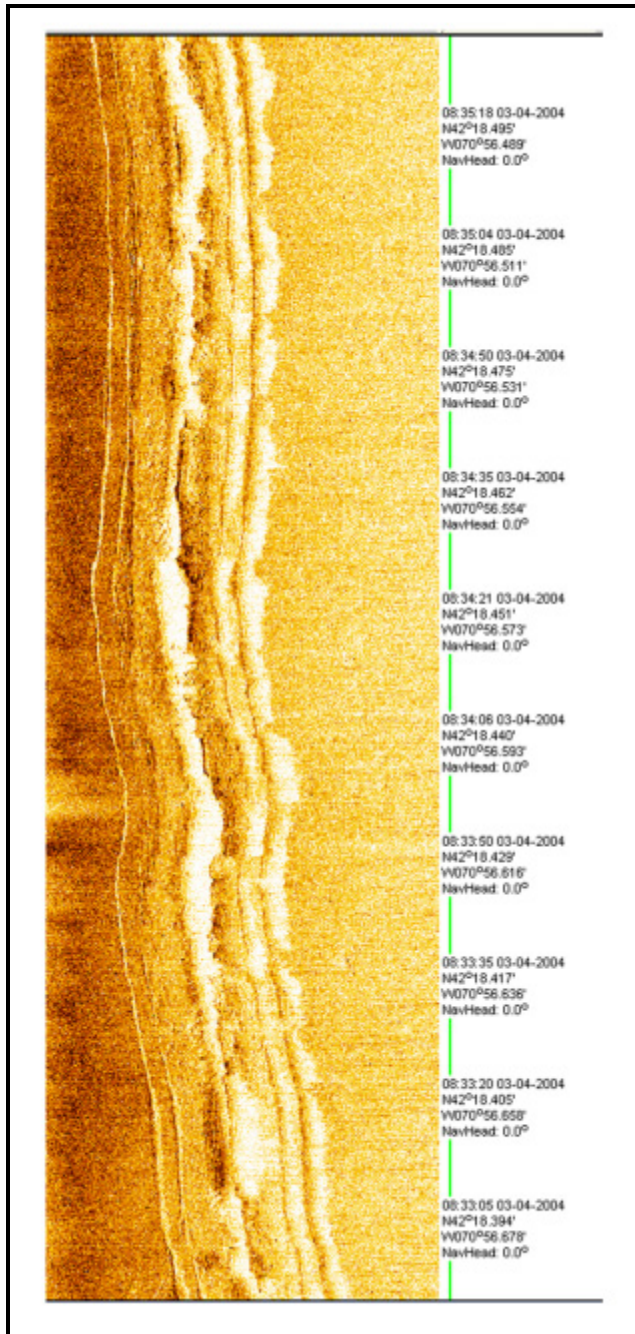
A20, Dive3, 0617 (Sonar record source: HubweymouthtoHull, 03/2004

Sonar Record Description for Dive 3: Coordinates: 42 18.4N / 070 56.6W

A plowed trench section in the shallow Nantasket Road waters. The plowed section is complex with berms and depressions linear to the path of the plow.

Video Record Description for Dive 3: This site was previously designated as A-20 and is in Nantasket Road. Coordinates: 42 18.4N / 070 56.6W. It was previously described, via sonar survey, as complex and interesting as related to the trenching. The ROV showed good trench after-effect profile with one lobster, a crab, and a minor variety of fish, including a chance “swim-by” by a sea raven.

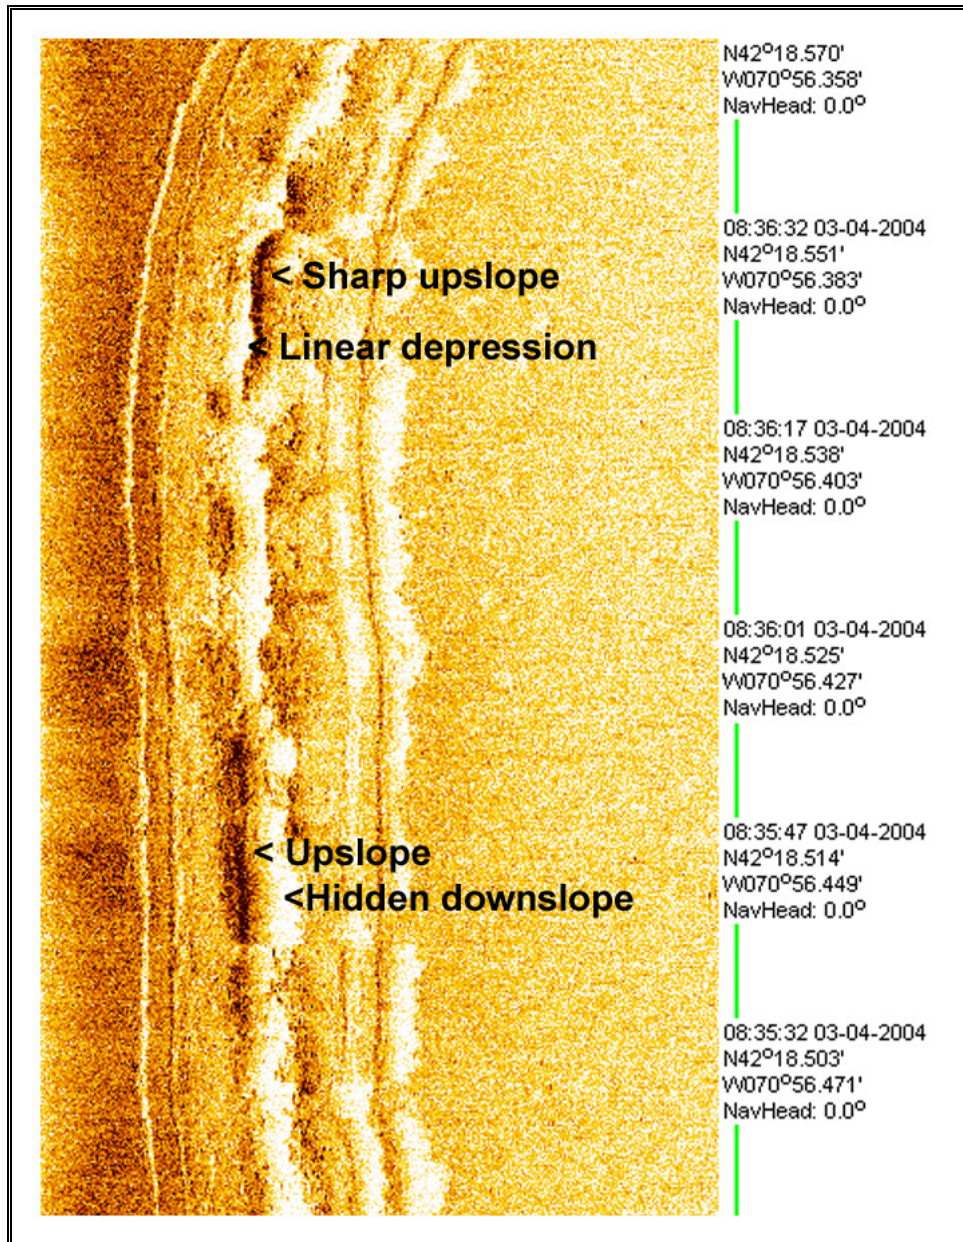
A25, Dive4, 0617 (Sonar record source: HubweymouthtoHull, 03/2004)

Sonar Record Description for Dive: Coordinates: 42 18.5N / 070 56.4W

A plowed trench section in the shallow Nantasket Road waters. This site is located next and NE of "A20". The A25 site has sand and gravel size substrate that shows some vertical features. Some of these are described. The plowed area is about 25m wide.

Video Record Description for Dive 4: This is A-25 as previously recorded. Coordinates: 42 18N / 070 56W
Although little growth was evident on the cobble and sea bottom, a modest amount of marine life was seen: skate, cunners, and crabs.
